The Road Inventory of Lost Trail National Wildlife Refuge Marion, MT

Prepared By:
Federal Highway Administration
Central Federal Lands Highway Division
August 2008

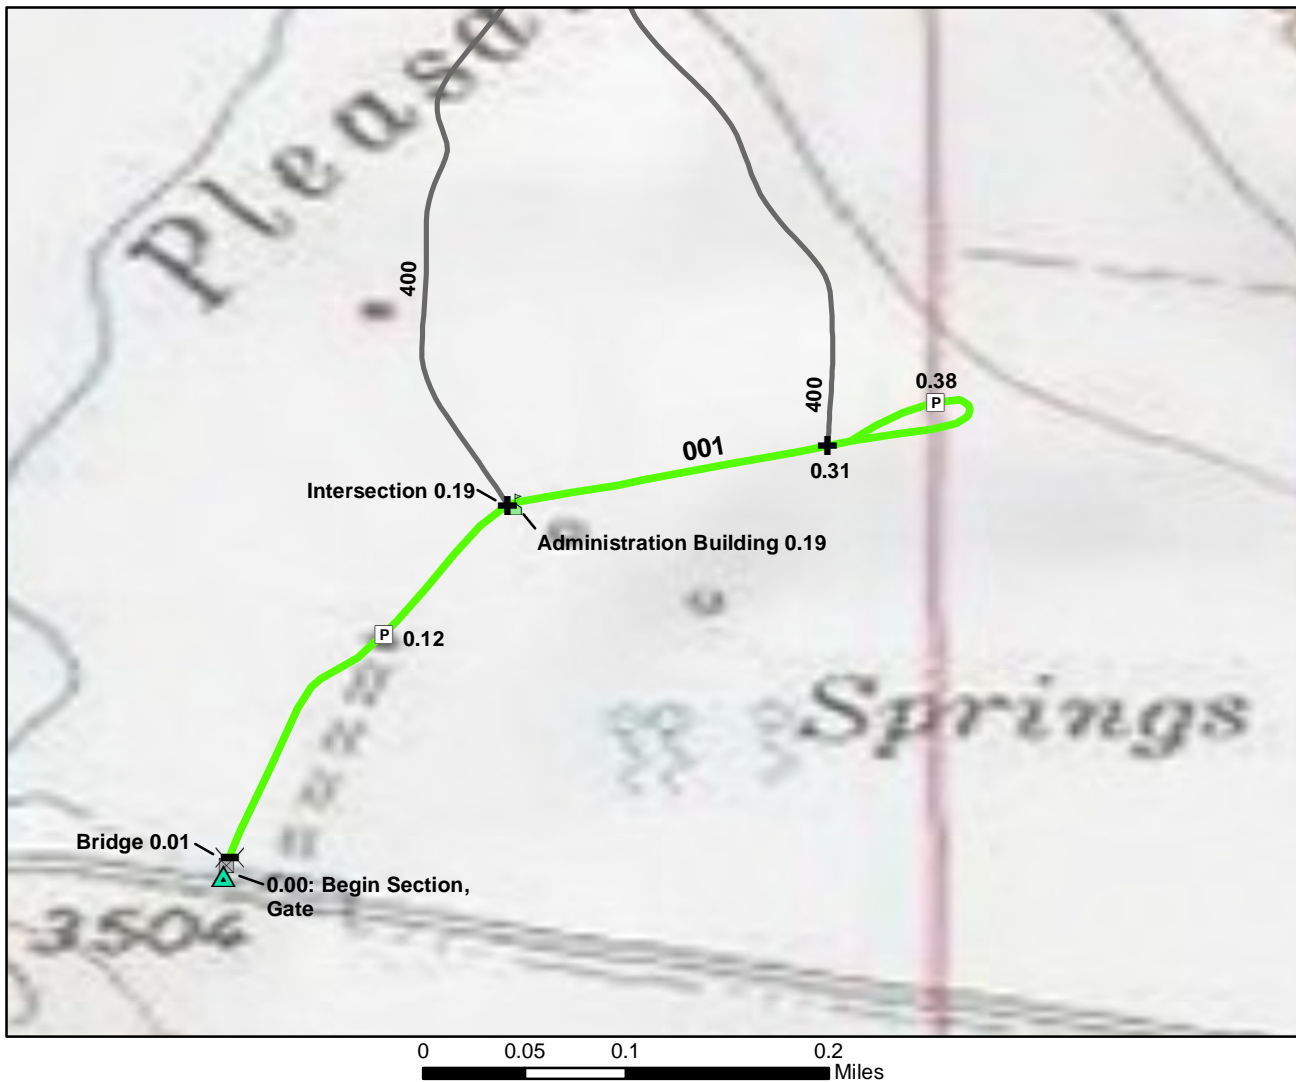
ROUTE: 010 HQ Entrance Road TOTAL LENGTH: 0.42 Miles

Section Number	001				
Section Length (miles)	0.42				
Inspection Date	8/22/2008				
Section Information					
Surface Type	Gravel				
Number of Lanes	1				
Roadway Width (feet)	14				
Roadway Condition Information					
Condition	Good				
Remaining Service Life (years)	7				
Cost Estimate	\$700				
CRV	\$278700

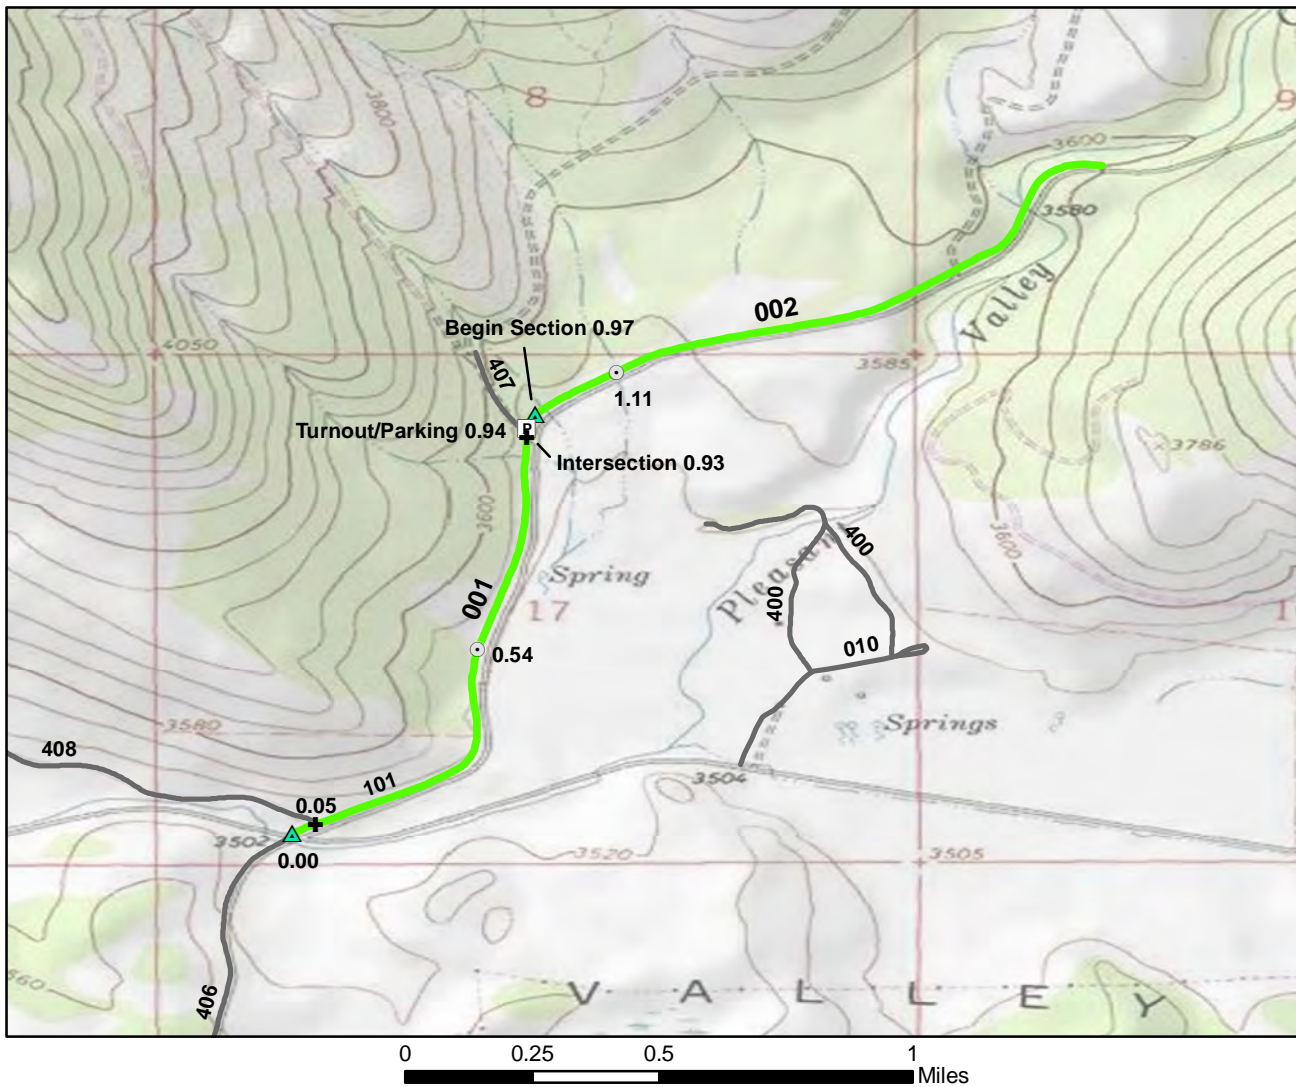
ROUTE: 101 Refuge Road 1019 TOTAL LENGTH: 1.92 Miles

Section Number	001	002			
Section Length (miles)	0.97	0.94			
Inspection Date	8/22/2008	8/22/2008			
Section Information					
Surface Type	Gravel	Gravel			
Number of Lanes	1	1			
Roadway Width (feet)	12	12			
Roadway Condition Information					
Condition	Good	Good			
Remaining Service Life (years)	5	7			
Cost Estimate	\$1500	\$1500			
CRV	\$645300	\$627300

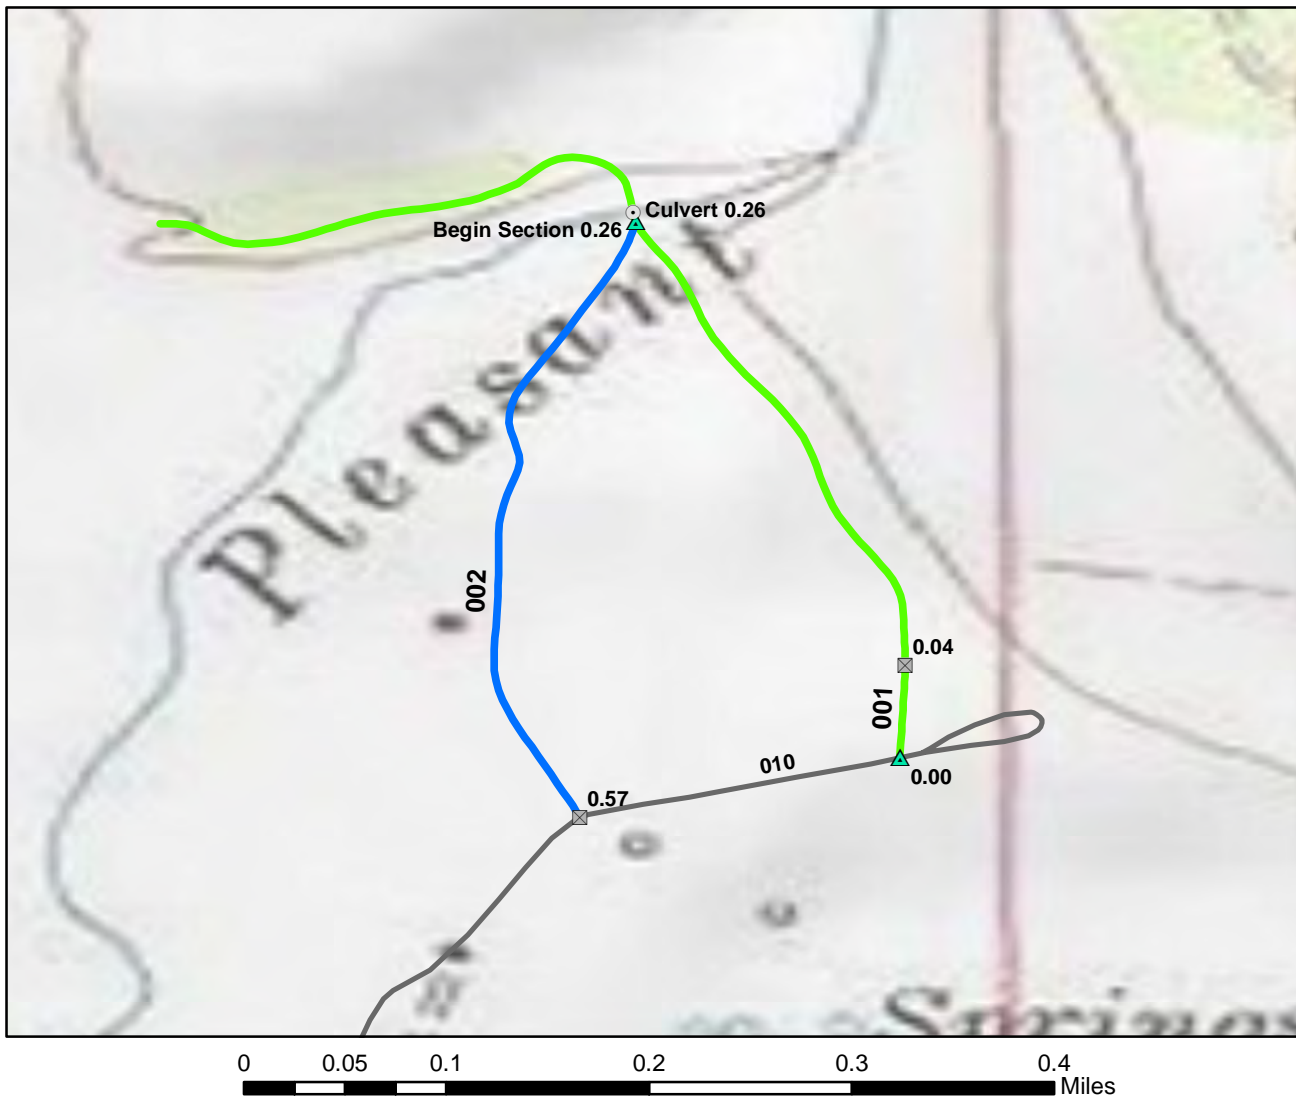
ROUTE: 400 Gravel Pit Access Road TOTAL LENGTH: 0.79 Miles

Section Number	001	002			
Section Length (miles)	0.48	0.31			
Inspection Date	8/22/2008	8/22/2008			
Section Information					
Surface Type	Gravel	Gravel			
Number of Lanes	1	1			
Roadway Width (feet)	12	10			
Roadway Condition Information					
Condition	Good	Excellent			
Remaining Service Life (years)	7	9			
Cost Estimate	\$700	\$0			
CRV	\$317000	\$205900

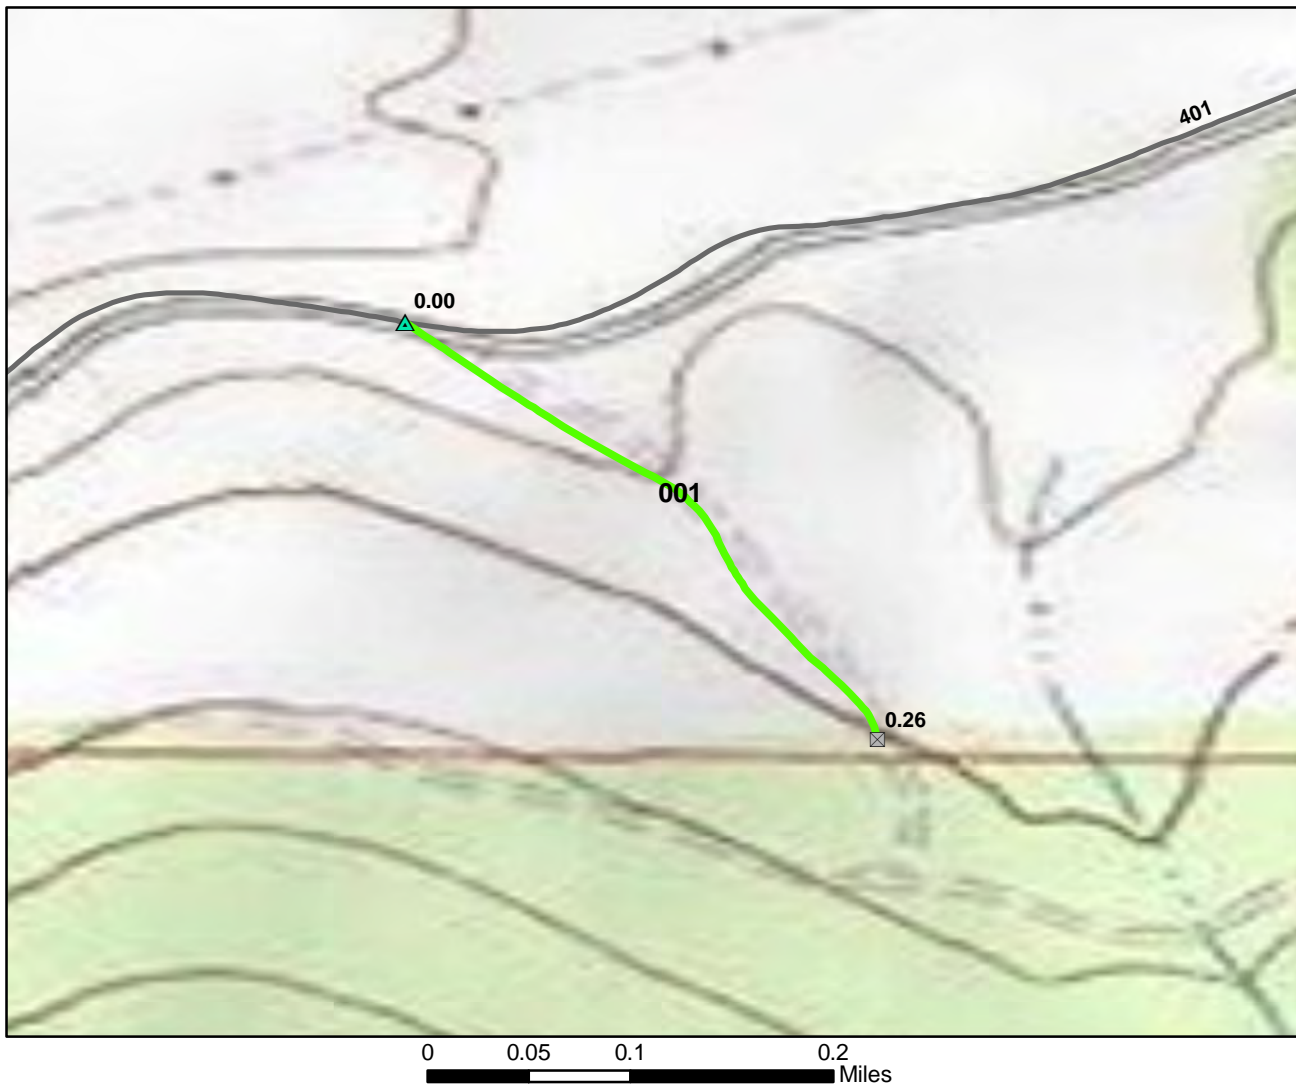
ROUTE: 402 North Lund Road TOTAL LENGTH: 0.26 Miles

Section Number	001				
Section Length (miles)	0.26				
Inspection Date	8/22/2008				
Section Information					
Surface Type	Native				
Number of Lanes	1				
Roadway Width (feet)	10				
Roadway Condition Information					
Condition	Good				
Remaining Service Life (years)	5				
Cost Estimate	\$400				
CRV	\$90400

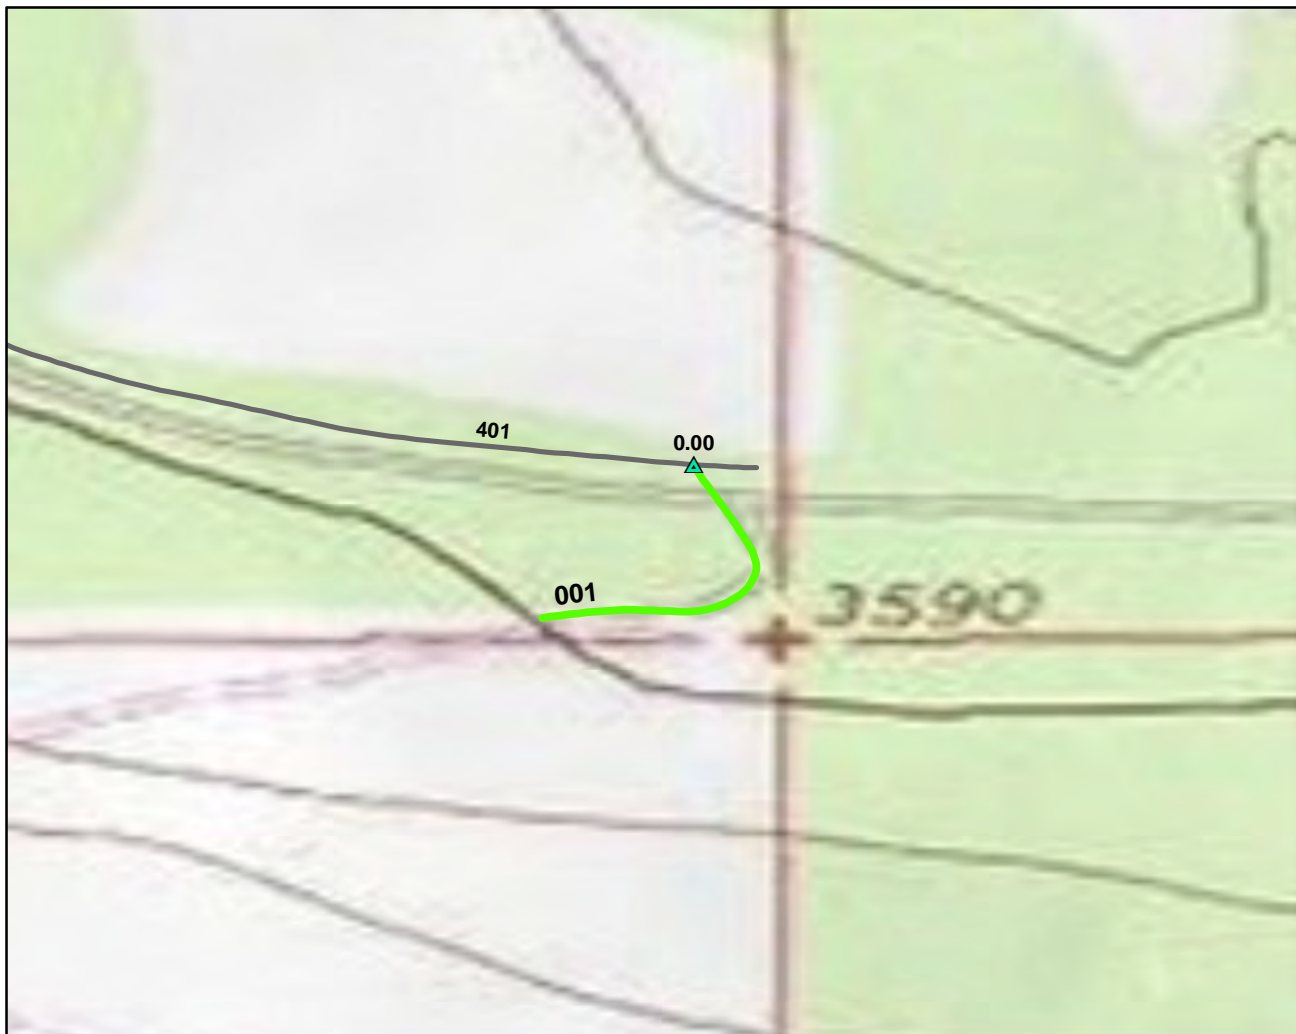
ROUTE: 403 Elliott Road TOTAL LENGTH: 0.14 Miles

Section Number	001				
Section Length (miles)	0.14				
Inspection Date	8/22/2008				
Section Information					
Surface Type	Native				
Number of Lanes	1				
Roadway Width (feet)	10				
Roadway Condition Information					
Condition	Good				
Remaining Service Life (years)	7				
Cost Estimate	\$200				
CRV	\$47400

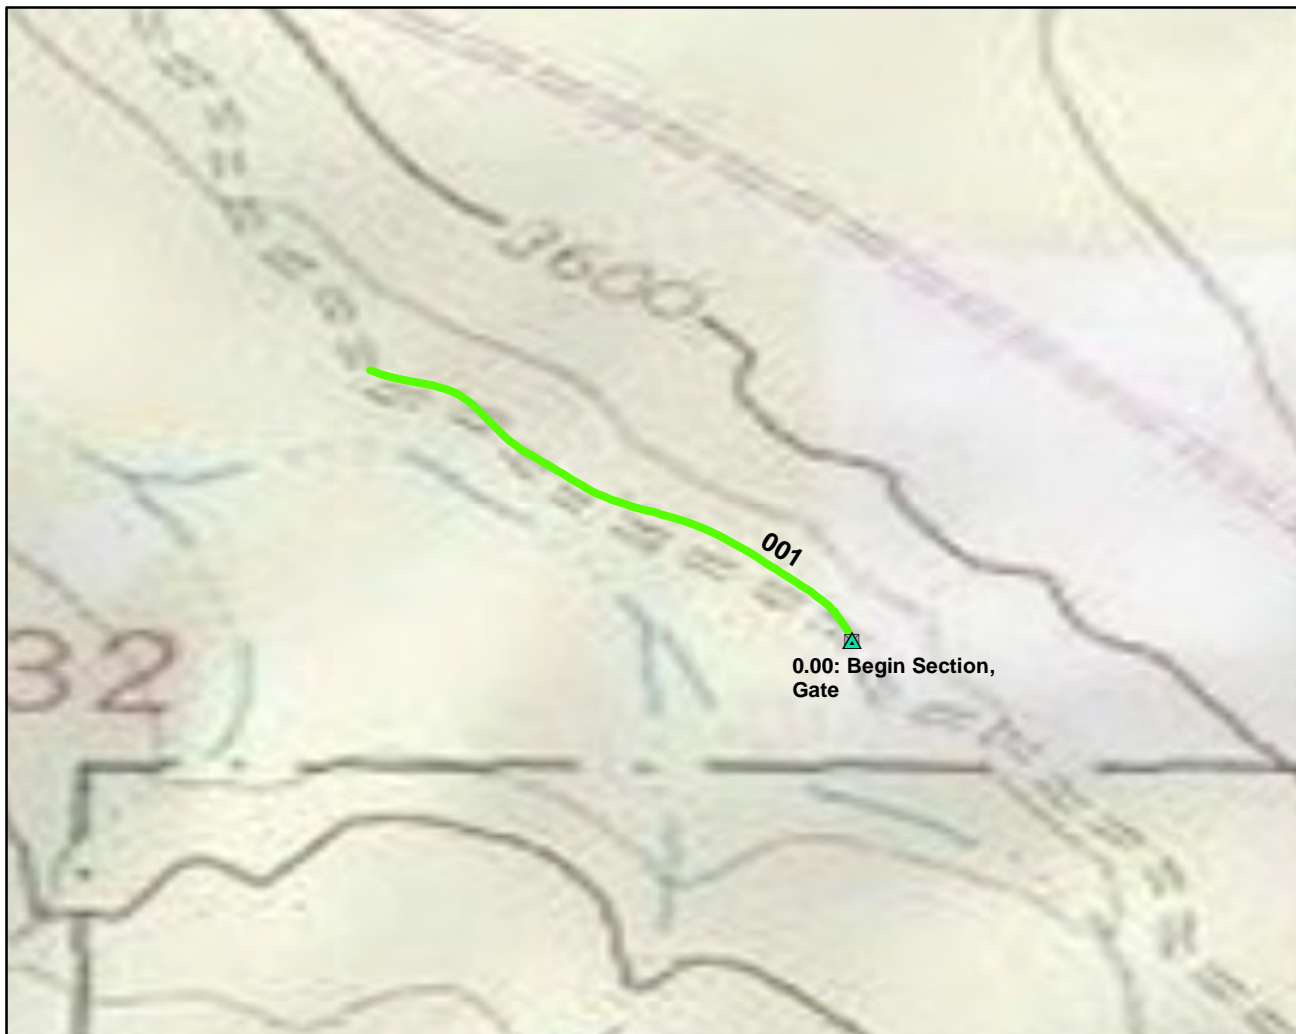
ROUTE: 404 Southeast Boundary Road TOTAL LENGTH: 0.21 Miles

Section Number	001				
Section Length (miles)	0.21				
Inspection Date	8/22/2008				
Section Information					
Surface Type	Native				
Number of Lanes	1				
Roadway Width (feet)	8				
Roadway Condition Information					
Condition	Good				
Remaining Service Life (years)	5				
Cost Estimate	\$400				
CRV	\$73500

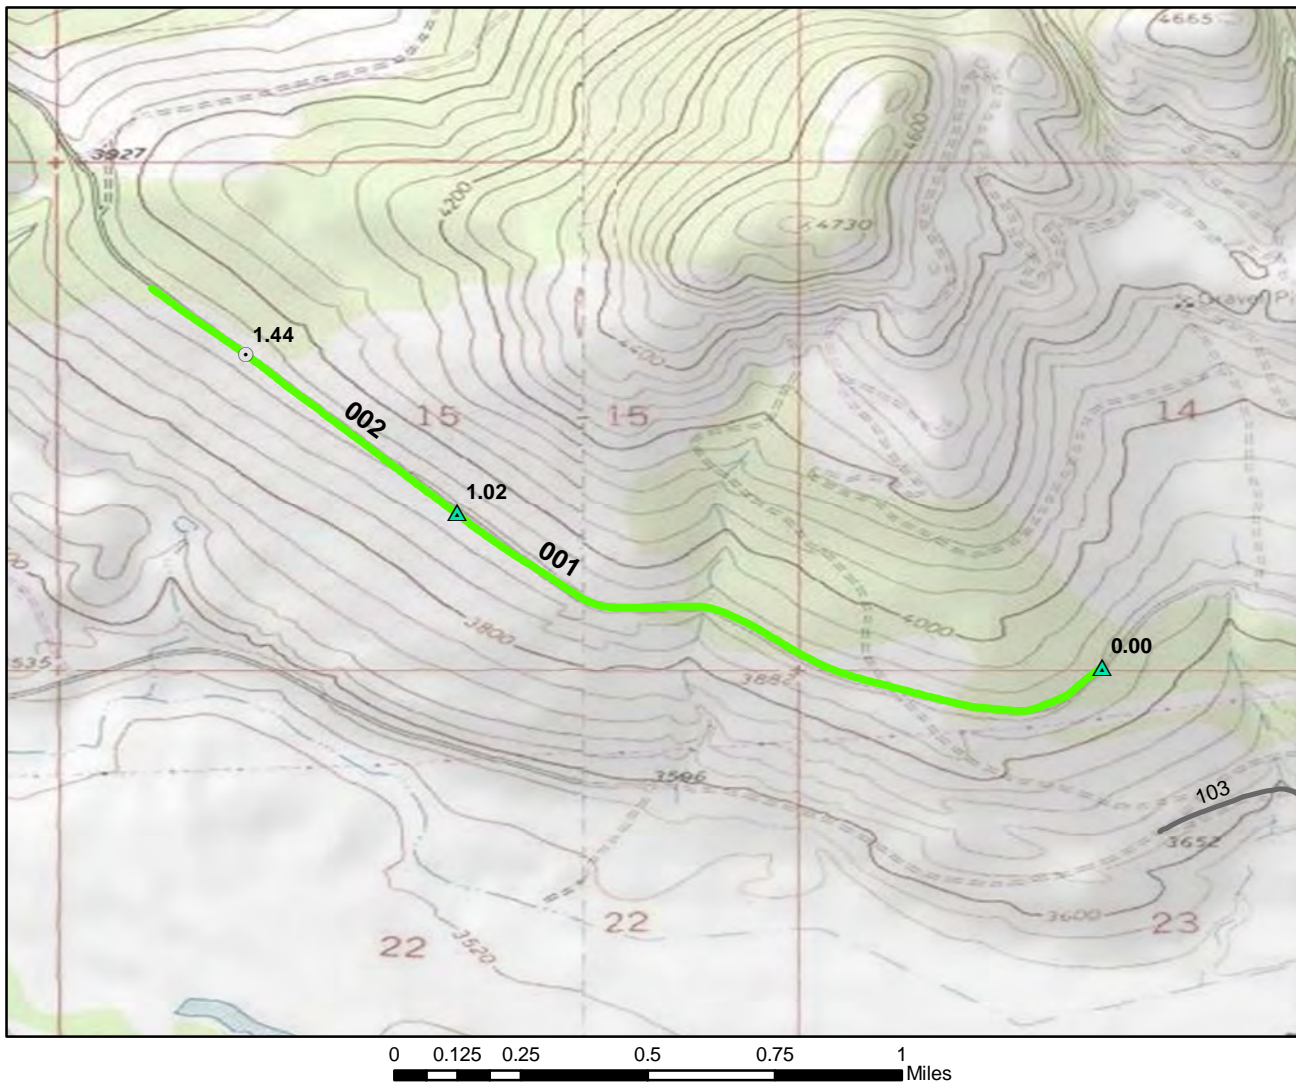
ROUTE: 405 North Pleasant Valley Road TOTAL LENGTH: 1.62 Miles

Section Number	001	002			
Section Length (miles)	1.02	0.60			
Inspection Date	8/22/2008	8/22/2008			
Section Information					
Surface Type	Gravel	Gravel			
Number of Lanes	1	1			
Roadway Width (feet)	10	10			
Roadway Condition Information					
Condition	Good	Good			
Remaining Service Life (years)	5	5			
Cost Estimate	\$1600	\$900			
CRV	\$675800	\$398100

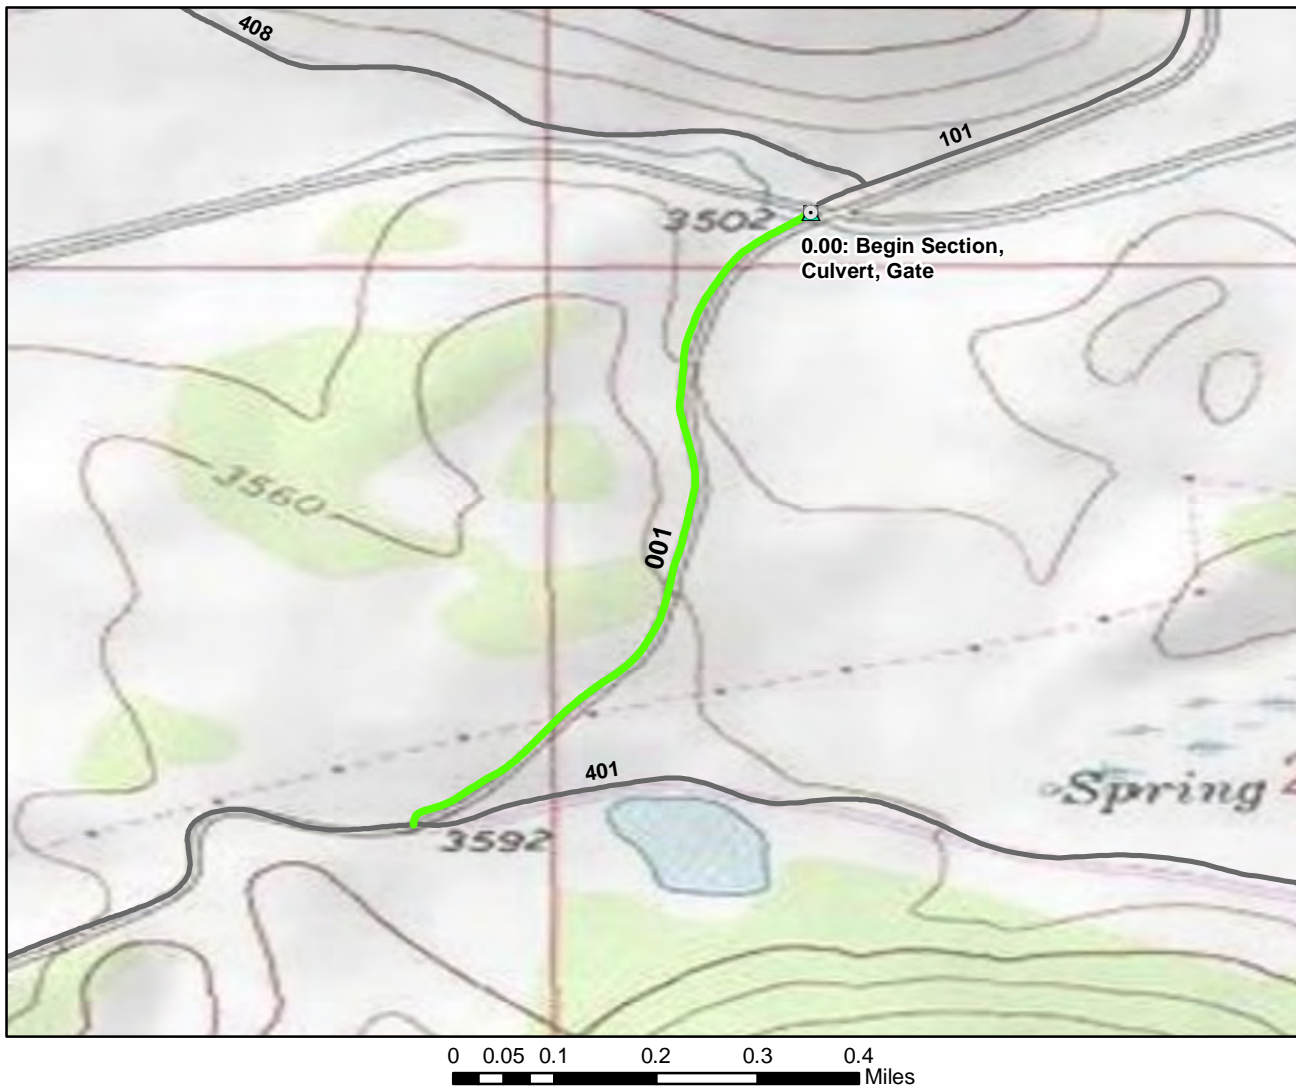
ROUTE: 406 Central South Pleasant Valley Access Road TOTAL LENGTH: 0.70 Miles

Section Number	001				
Section Length (miles)	0.70				
Inspection Date	8/22/2008				
Section Information					
Surface Type	Gravel				
Number of Lanes	1				
Roadway Width (feet)	12				
Roadway Condition Information					
Condition	Good				
Remaining Service Life (years)	5				
Cost Estimate	\$1100				
CRV	\$464000

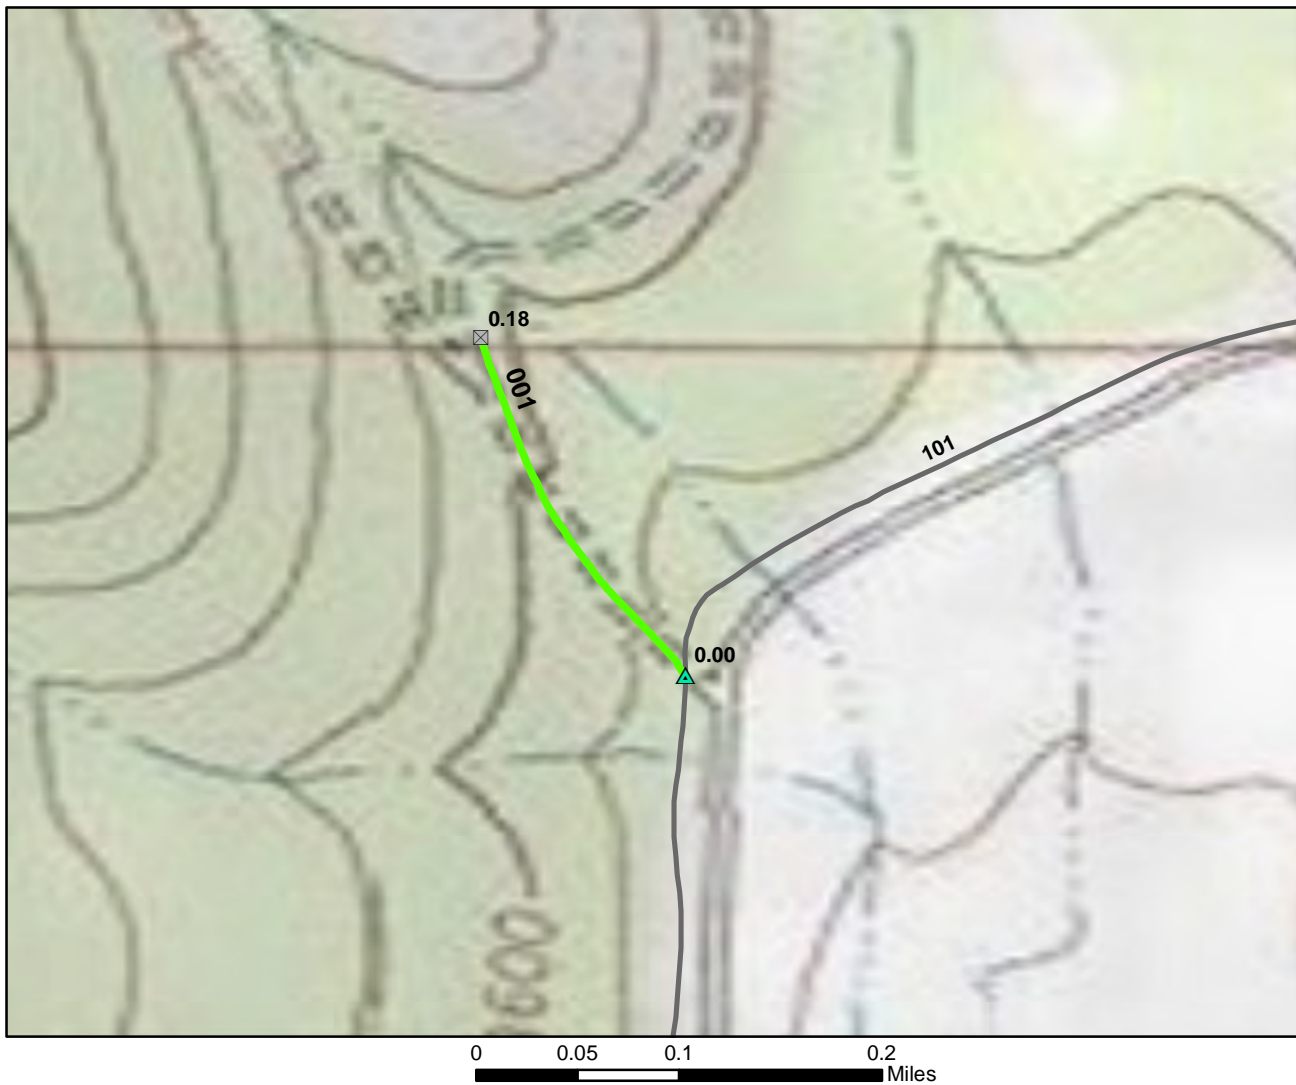
ROUTE: 407 Bliese Road TOTAL LENGTH: 0.18 Miles

Section Number	001				
Section Length (miles)	0.18				
Inspection Date	8/22/2008				
Section Information					
Surface Type	Native				
Number of Lanes	1				
Roadway Width (feet)	8				
Roadway Condition Information					
Condition	Good				
Remaining Service Life (years)	7				
Cost Estimate	\$300				
CRV	\$62300

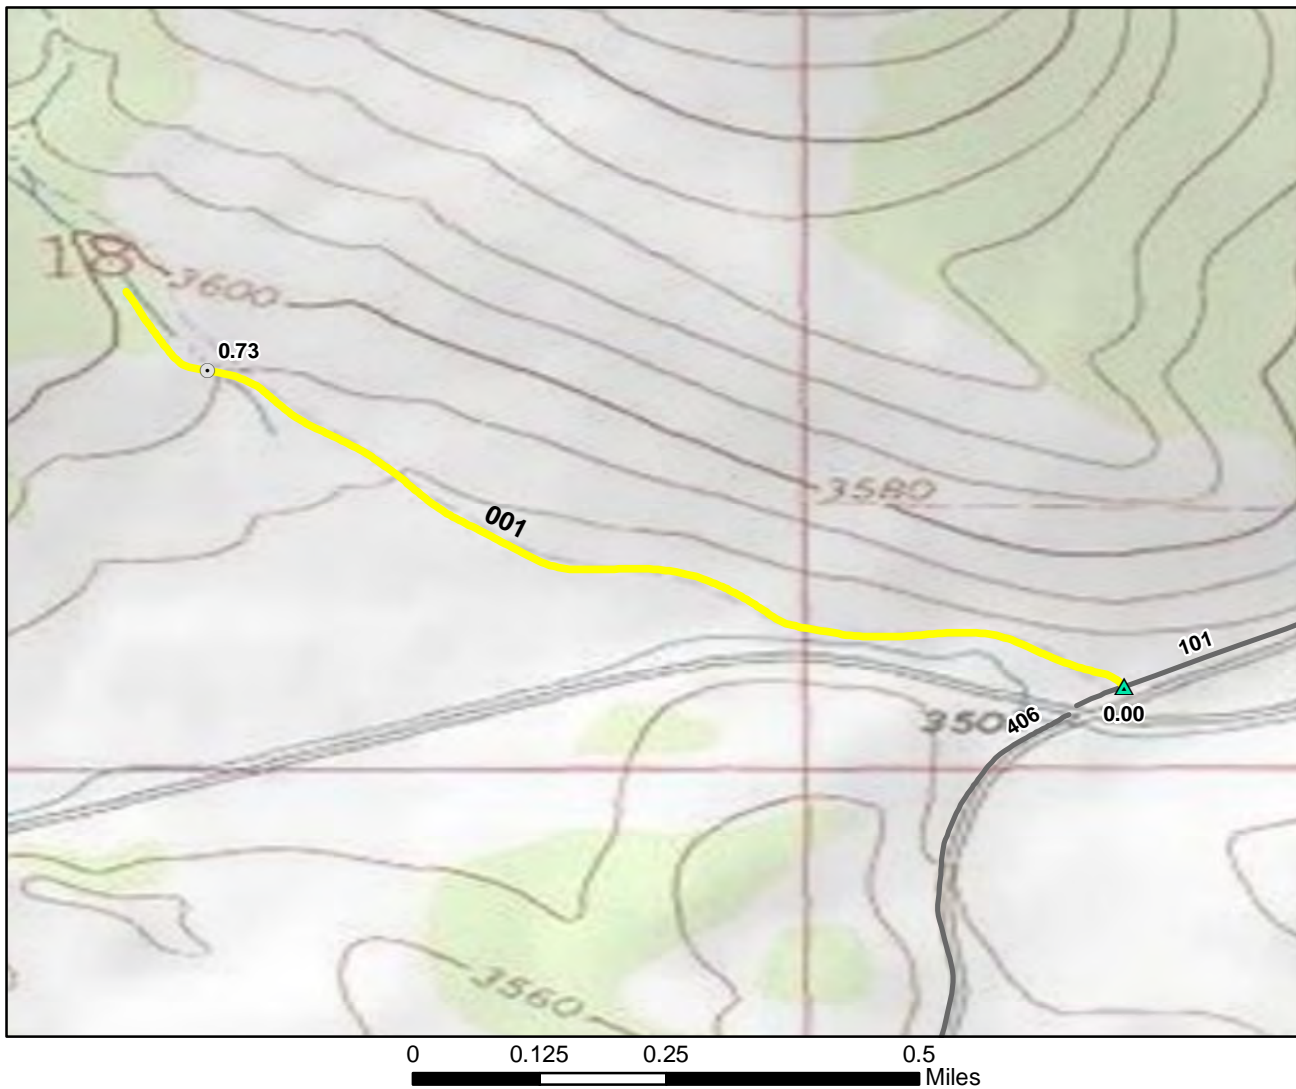
ROUTE: 408 1019 Spur Road TOTAL LENGTH: 0.81 Miles

Section Number	001				
Section Length (miles)	0.81				
Inspection Date	8/22/2008				
Section Information					
Surface Type	Native				
Number of Lanes	1				
Roadway Width (feet)	8				
Roadway Condition Information					
Condition	Fair				
Remaining Service Life (years)	4				
Cost Estimate	\$1700				
CRV	\$279400

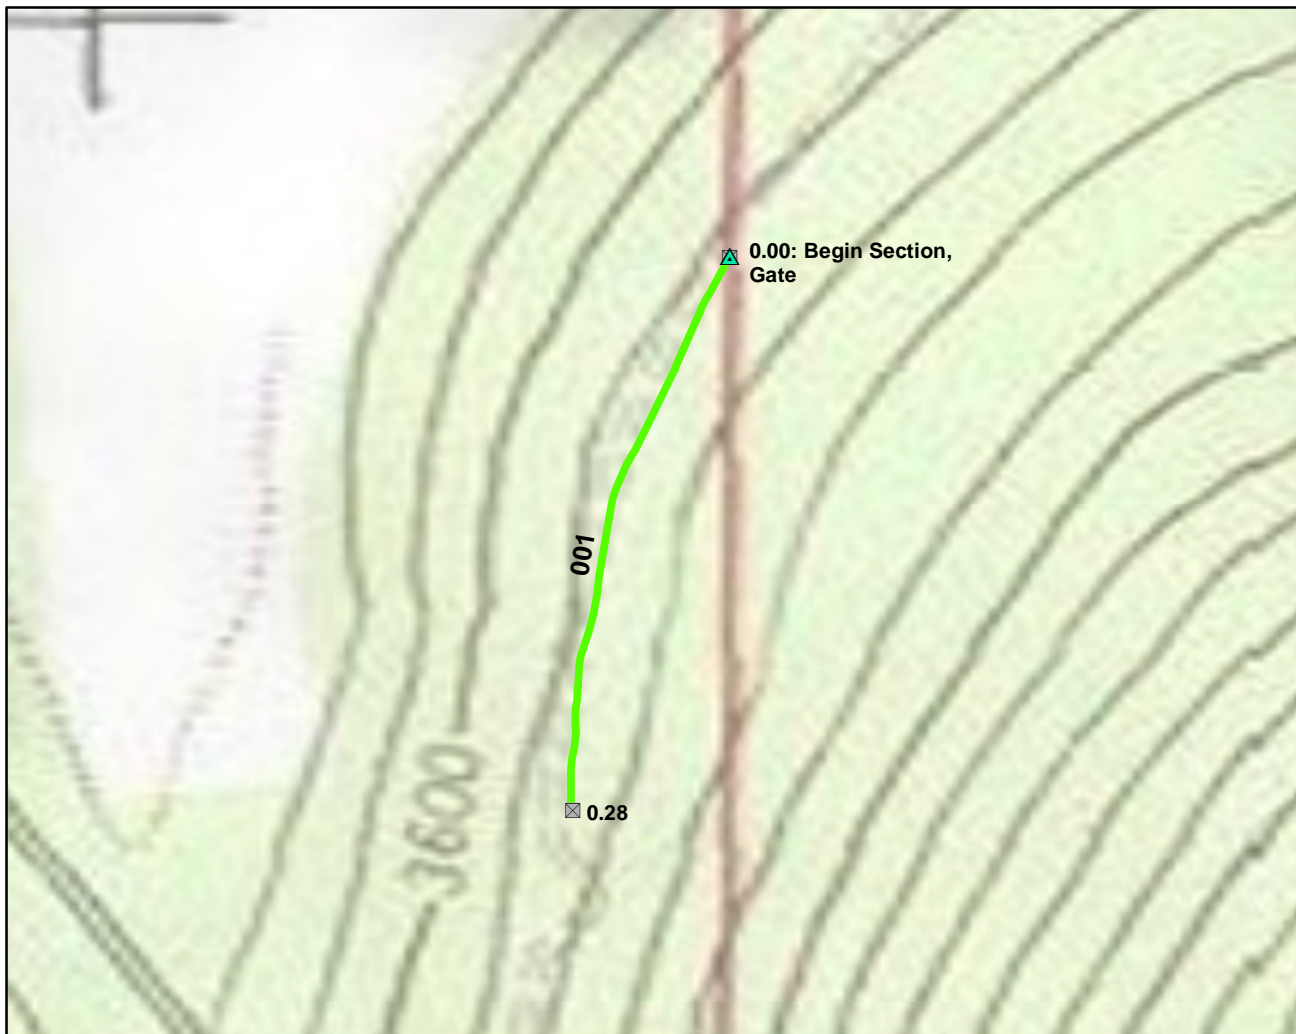
ROUTE: 410 South Lund Road TOTAL LENGTH: 0.28 Miles

Section Number	001				
Section Length (miles)	0.28				
Inspection Date	8/22/2008				
Section Information					
Surface Type	Native				
Number of Lanes	1				
Roadway Width (feet)	10				
Roadway Condition Information					
Condition	Good				
Remaining Service Life (years)	7				
Cost Estimate	\$500				
CRV	\$96300

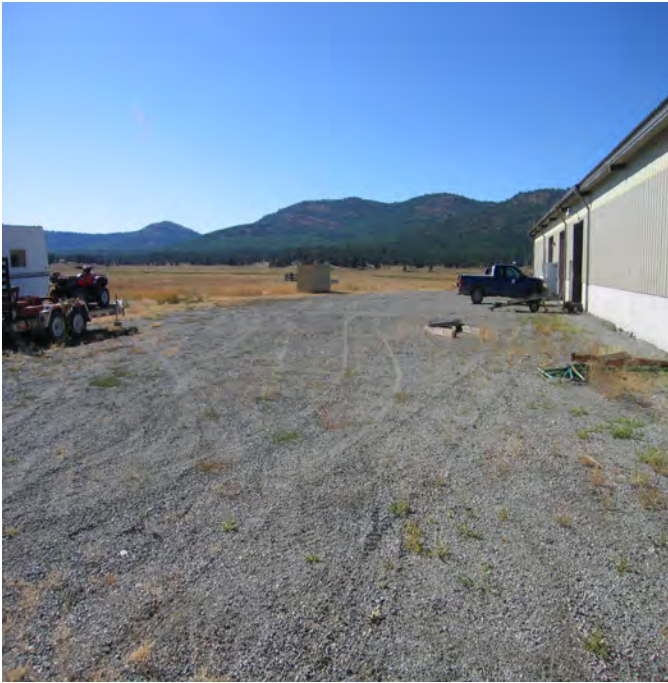
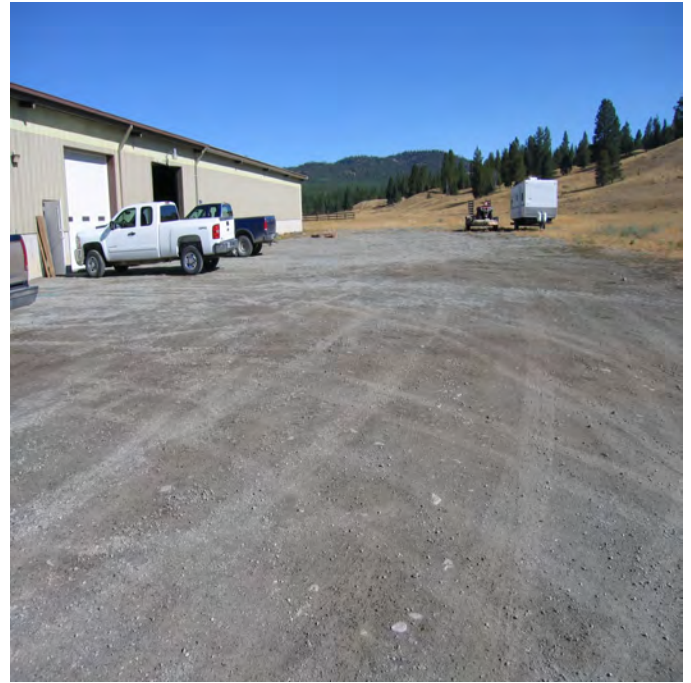
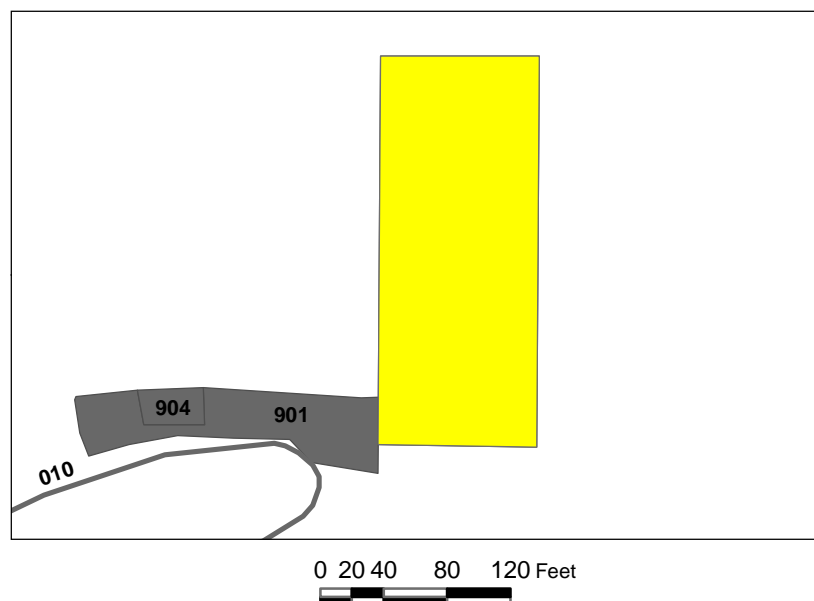
Route 800: Shop Parking

Asset Number	Date Visited	Surface Type	Area (sq ft)	Condition	Cost to Improve
10026507	8/22/2008	Gravel	16560	Fair	\$4200

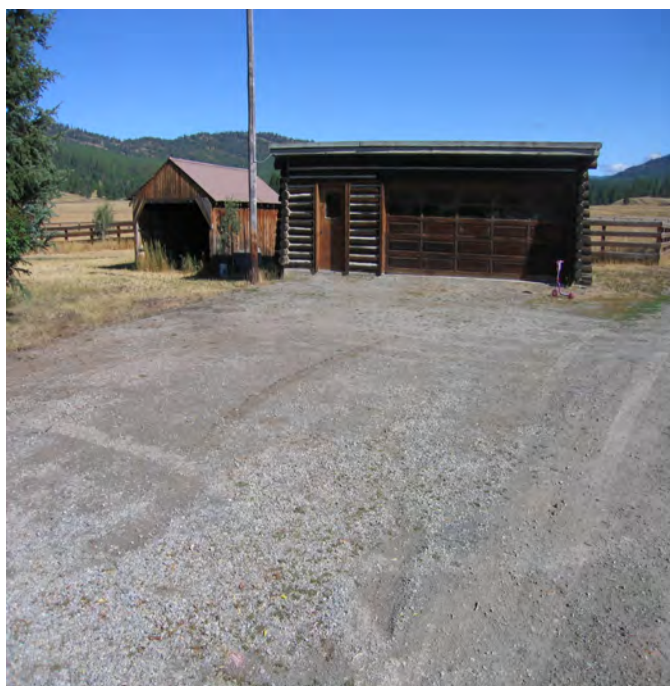
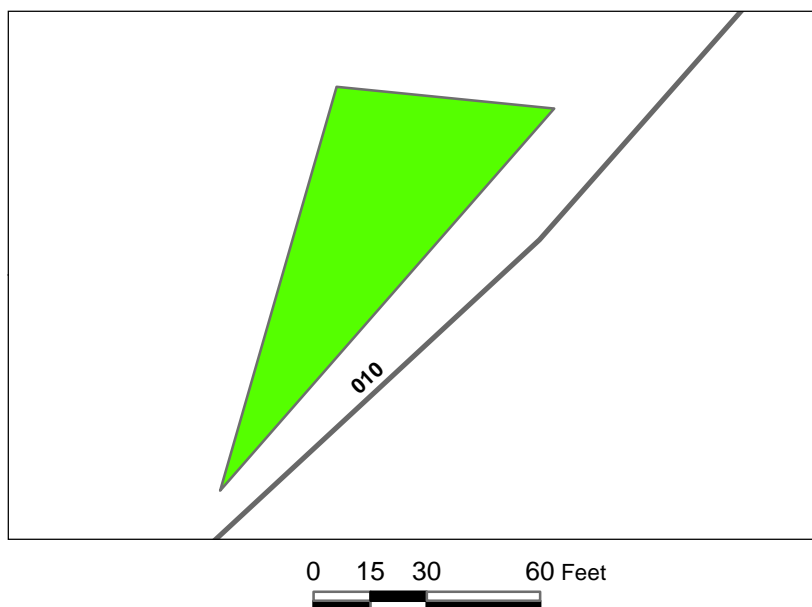
Route 801: Residence Parking

Asset Number	Date Visited	Surface Type	Area (sq ft)	Condition	Cost to Improve
10026507	8/22/2008	Gravel	2113	Good	\$300

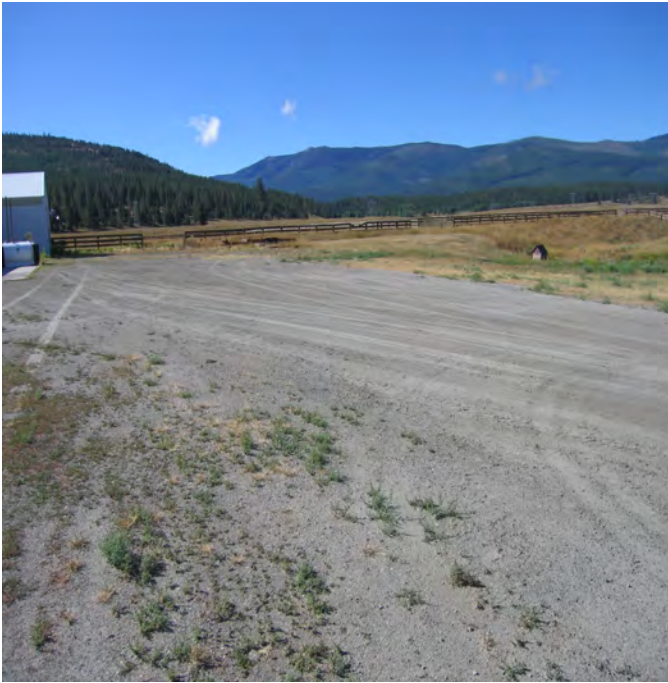
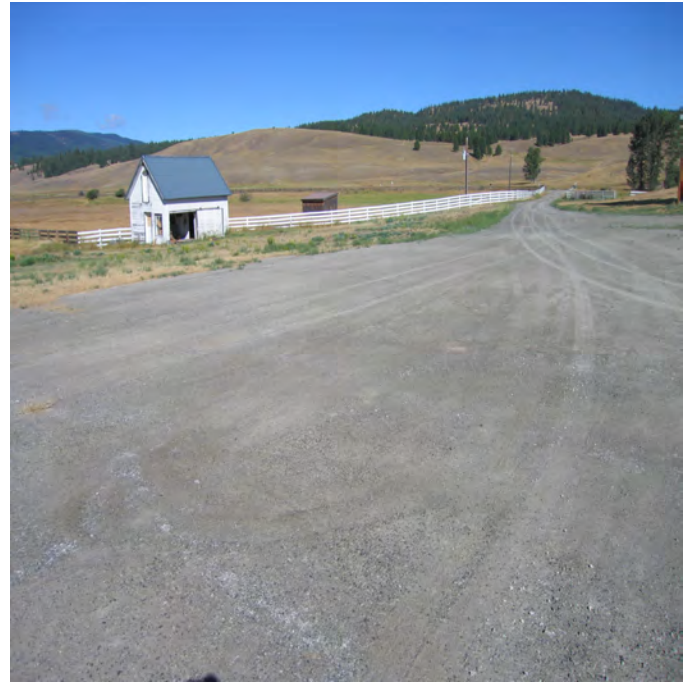
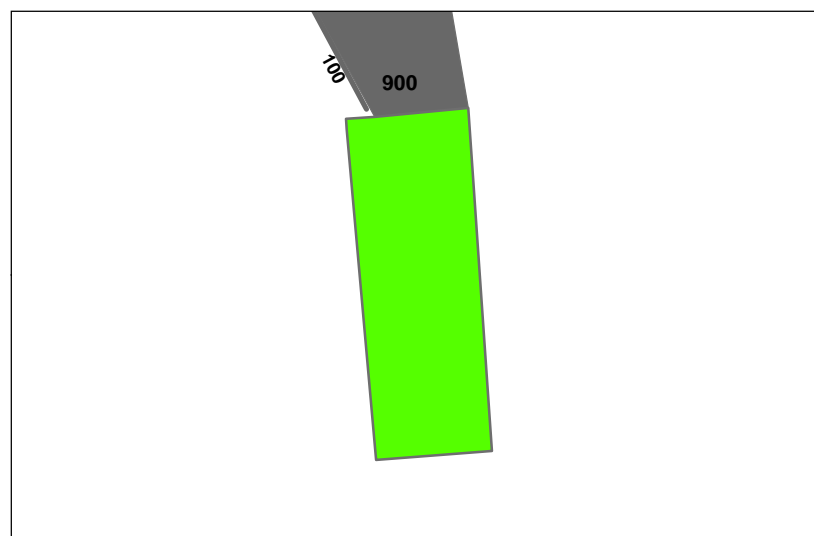
Route 802: Old HQ Shop Parking

Asset Number	Date Visited	Surface Type	Area (sq ft)	Condition	Cost to Improve
10026507	8/22/2008	Gravel	13272	Good	\$1900

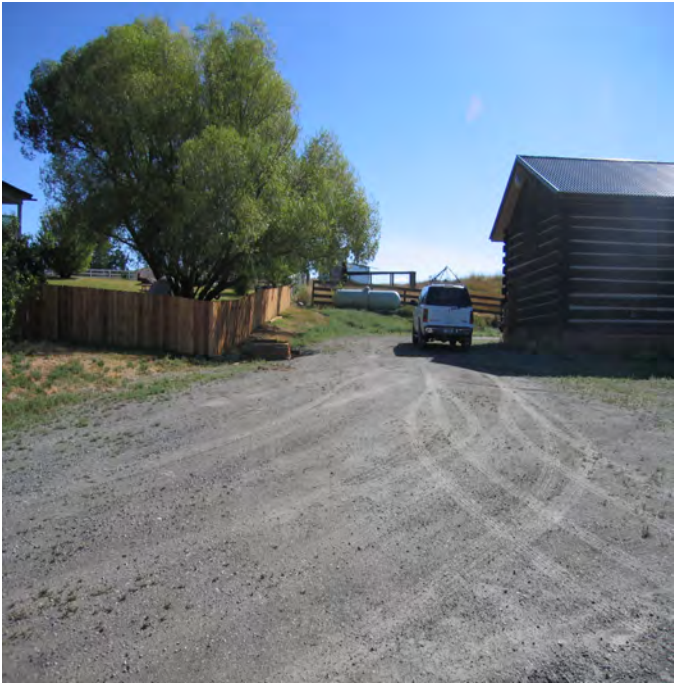
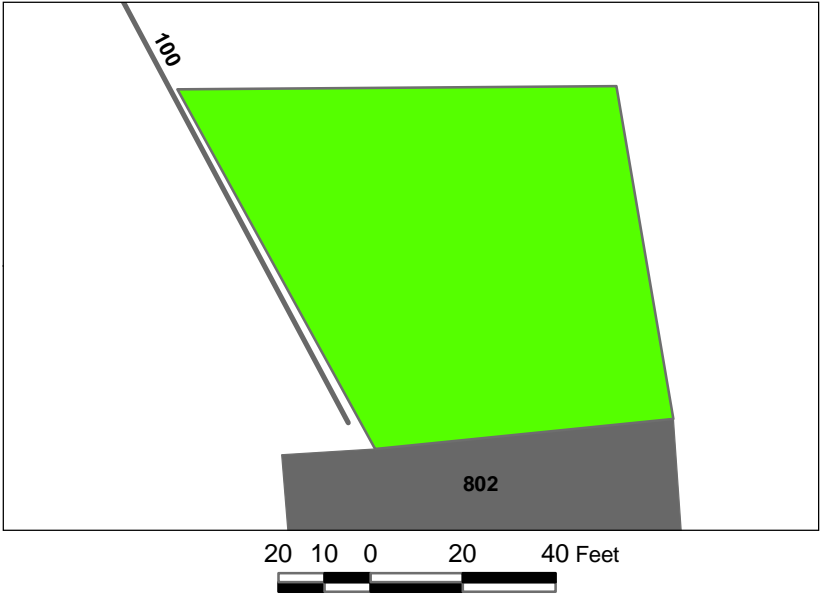
Route 900: Old HQ Parking

Asset Number	Date Visited	Surface Type	Area (sq ft)	Condition	Cost to Improve
10026508	8/22/2008	Gravel	4095	Good	\$600

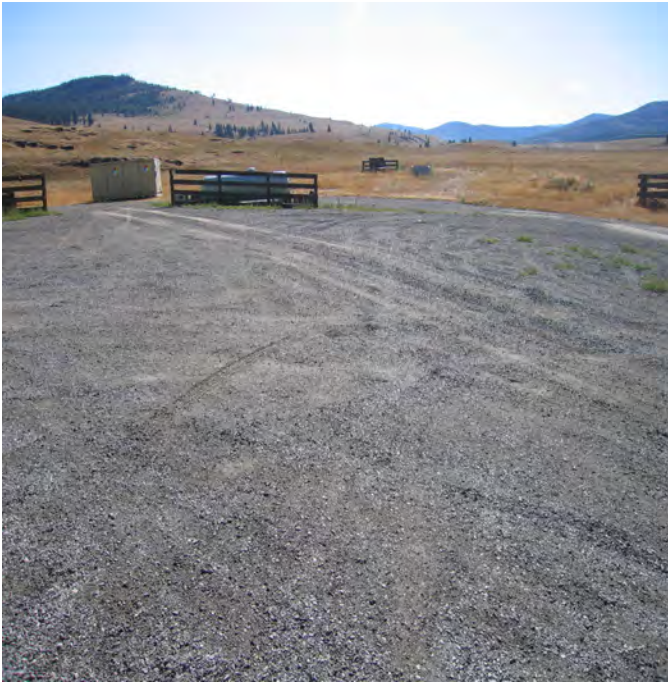
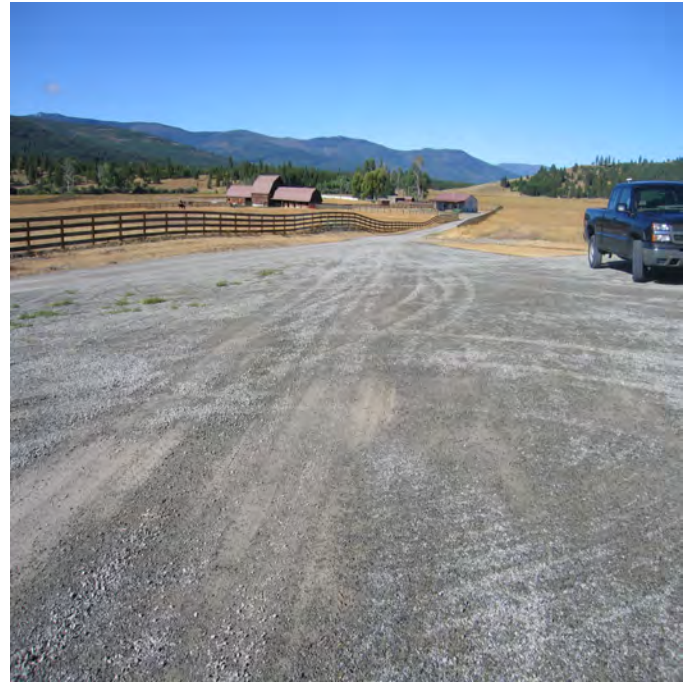
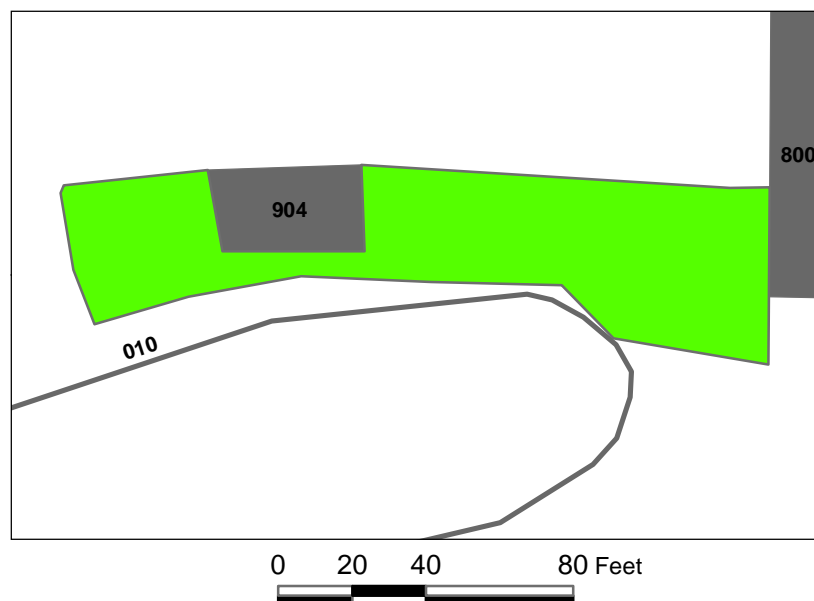
Route 901: HQ/VC Parking

Asset Number	Date Visited	Surface Type	Area (sq ft)	Condition	Cost to Improve
	8/22/2008	Gravel	3851	Good	600
